**Flood Control Project Maintenance
Levee Inspections**

Maintenance Issue Types Only, Levee Inspection Report By Mile - Fall 2018

Reclamation District No. 1602 Del Puerto

Waterway	Bank	Unit Miles	Inspection Start/End	Inspector
Unit No. 01 San Joaquin River	Left	6.24	11/06/2018 11/06/2018	Corey Fujitani

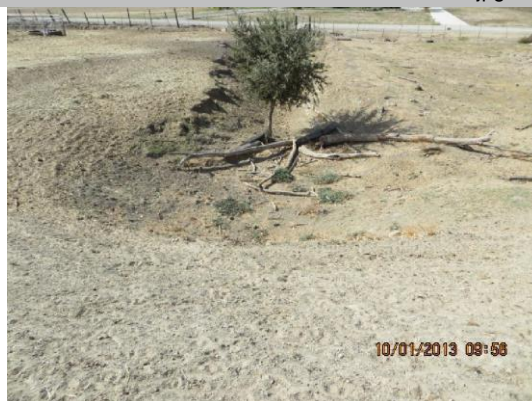
Photo 1 of 3 : UCIP_FA_2018_51634_36723.jpg

Inlet on LS toe.

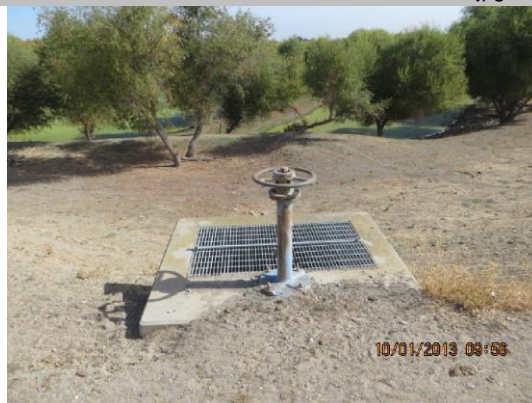
Photo 2 of 3 : UCIP_FA_2018_51634_36722.jpg

Slide gate in concrete box on WS shoulder.

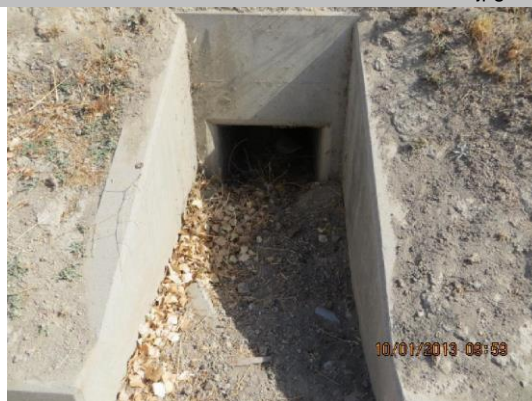
Photo 3 of 3 : UCIP_FA_2018_51634_36721.jpg

Item	DWR UCIP LMA Responsibility			37.477993 °	37.477993 °	
				-121.072645 °	-121.072645 °	
DWR ID	20216					
Comment Code						
Inspector Comment						
FS_ID:51634 DS_ID:20216 EP_NO: N/A Repair Type: No Action Needed Crossing Status: Found UCIP Comments: 11/18/2016 Crossing has been downgraded from Urgent to No Action Needed the debris blocking the outlet has been cleared. (O. Magana - DWR UCIP)10/01/2013 Flap gate blocked from functioning by soil buildup on WS toe. Soil should be cleared. (W. Wylie - DWR UCIP) FIELD_STRUCT_DESC: 30-inch square reinforced concrete box culvert through levee, 14.4 feet below crown. Concrete "U" headwall on the waterside (WS) and landside (LS) ends. Slide gate in 6-foot by 7-foot concrete surge box is located on the WS shoulder. Flap gate is located on the WS end. [Additional Reference(s): DWR Levee Log, 1992. USACE San Joaquin River O&M Manual Unit 13, April 1964, (HLM 0.78), Drawing No. 7-4-1784]. FS Date: 11/18/2016

Concrete inlet on LS toe.

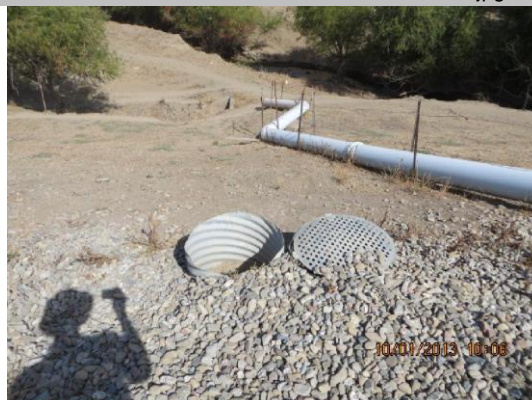
Photo 2 of 3 : UCIP_FA_2018_51636_36757.jpg

Comment Code						
Inspector Comment						
FS_ID:51636 DS_ID:20217 EP_NO: N/A Repair Type: Non-Urgent Crossing Status: Found UCIP Comments: 11/18/2016 Crossing has been downgraded from Urgent to Non-Urgent a flap gate has been added to the WS but pipe is currently not connected to pump. According to Tony Martinez, LMA representative, this crossing is currently not in use. Owner will need to coordinate with CVFPB to obtain permit. (O. Magana - DWR UCIP)10/01/2013 Appears abandoned and if so should be done so properly. Flapgate missing. (W. Wylie - DWR UCIP) FIELD_STRUCT_DESC: *ABANDONED* 1 of 2: 16-inch steel drainage pipe through levee, 17 feet below crown. Pumps on the pump platform are located on the landside (LS). Siphon breaker in 24-inch corrugated metal pipe (CMP) riser is located on the waterside (WS) shoulder. Concrete "U" headwall and flap gate are located on the WS end. [Additional Reference(s): DWR Levee Log, 1992. USACE San Joaquin River O&M Manual Unit 13, April 1964, (HLM 1.01), Drawing No. 7-4-1784]. FS Date: 11/18/2016

Siphon breaker in 24-inch CMP riser on WS shoulder.

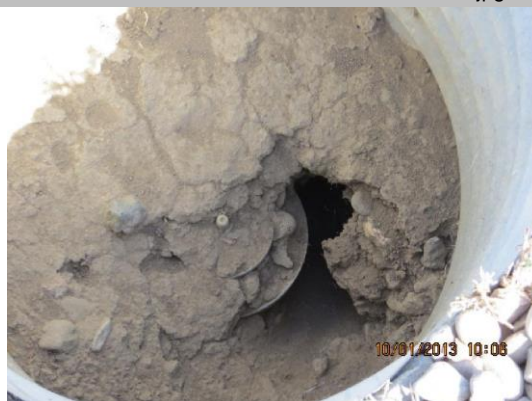
Photo 3 of 3 : UCIP_FA_2018_51636_36756.jpg

Item	DWR UCIP LMA Responsibility		37.478816°	37.478816°								
			-121.068780°	-121.068780°								
DWR ID	20217											
Comment Code												
Inspector Comment												
FS_ID:51636 DS_ID:20217 EP_NO: N/A Repair Type: Non-Urgent Crossing Status: Found UCIP Comments: 11/18/2016 Crossing has been downgraded from Urgent to Non-Urgent a flap gate has been added to the WS but pipe is currently not connected to pump. According to Tony Martinez, LMA representative, this crossing is currently not in use. Owner will need to coordinate with CVFPB to obtain permit. (O. Magana - DWR UCIP)10/01/2013 Appears abandoned and if so should be done so properly. Flapgate missing. (W. Wylie - DWR UCIP) FIELD_STRUCT_DESC: *ABANDONED* 1 of 2: 16-inch steel drainage pipe through levee, 17 feet below crown. Pumps on the pump platform are located on the landside (LS). Siphon breaker in 24-inch corrugated metal pipe (CMP) riser is located on the waterside (WS) shoulder. Concrete "U" headwall and flap gate are located on the WS end. [Additional Reference(s): DWR Levee Log, 1992. USACE San Joaquin River O&M Manual Unit 13, April 1964, (HLM 1.01), Drawing No. 7-4-1784]. FS Date: 11/18/2016

Siphon breaker in 24-inch CMP riser on WS shoulder.

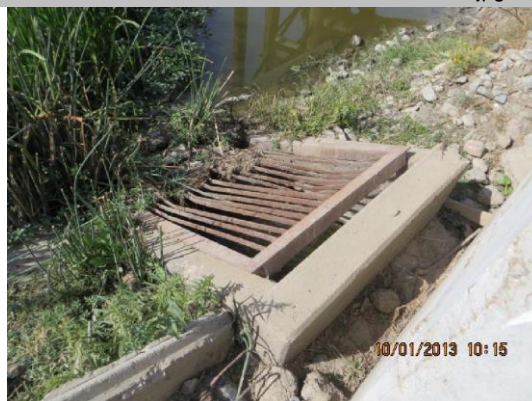
Photo 2 of 3 : UCIP_FA_2018_53521_36785.jpg

Comment Code						
Inspector Comment						
FS_ID:53521 DS_ID:20218 EP_NO: N/A Repair Type: Urgent Crossing Status: Found UCIP Comments: 10/19/2018 Pipe remains the same. WS concrete headwall is still detached with vertical erosion on the WS slope. Dense vegetation along pipe alignment made it difficult to inspect levee slopes and identify any potential issues present at this site. Recommend clearing vegetation along pipe alignment to be able to conduct a proper UCIP inspection. This crossing is part of DWR's Flood System Repair Project (FSRP) and Deferred Maintenance Project (DMP). Crossing will be monitored to identify progress of erosion on the WS slope. Crossing remains Urgent due to the detachment of the concrete wall and vertical cut on the WS. (O. Magana - DWR UCIP)11/18/2016 Same as previous inspection headwall on the WS toe has seperated from pipe and flap gate is still missing. Erosion around concrete headwall and undermined WS slope are visible from WS. The slope undermined appears to have progressed but no photos were taken due to the dense vegetation covering area. According to Tony Martinez, LMA representative, the WS concrete headwall has been detached since 2008/2009. LMA has been in contact with CVFPB, DWR, and USACE regarding this site. (O. Magana - DWR UCIP)10/01/2013 Headwall on WS toe seperated from pipe. Erosion around concrete headwall and undermined at WS toe. Flap gate missing from WS toe headwall. (W. Wylie - DWR UCIP) FIELD_STRUCT_DESC: 30-inch square reinforced concrete box culvert through levee, 25.4 feet below crown. Concrete "U" headwalls on both waterside (WS) and landside (LS) ends. Slide gate in concrete surge box located on the WS slope. A 5-foot by 5-foot concrete box is located on LS toe. Flap gate is located on the WS end. [Additional Reference(s): DWR Levee Log, 1992. USACE San Joaquin River O&M Manual Unit 13, April 1964, (HLM 1.02), Drawing No. 7-4-1784]. FS Date: 10/19/2018 10:23:00 AM

Grated inlet at LS toe.

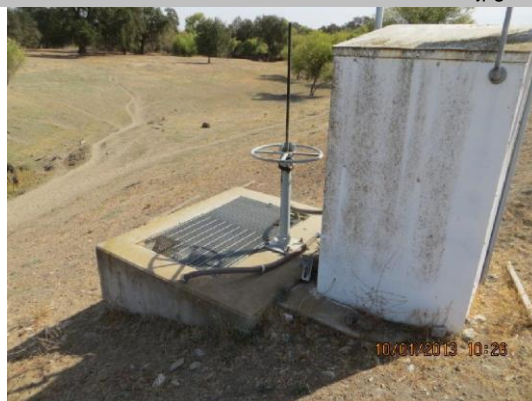
Photo 3 of 3 : UCIP_FA_2018_53521_36789.jpg

UCIP Comments: 10/19/2018 Pipe remains the same. WS concrete headwall is still detached with vertical erosion on the WS slope. Dense vegetation along pipe alignment made it difficult to inspect levee slopes and identify any potential issues present at this site. Recommend clearing vegetation along pipe alignment to be able to conduct a proper UCIP inspection. This crossing is part of DWR's Flood System Repair Project (FSRP) and Deferred Maintenance Project (DMP). Crossing will be monitored to identify progress of erosion on the WS slope. Crossing remains Urgent due to the detachment of the concrete wall and vertical cut on the WS. (O. Magana - DWR UCIP)11/18/2016 Same as previous inspection headwall on the WS toe has separated from pipe and flap gate is still missing. Erosion around concrete headwall and undermined WS slope are visible from WS. The slope undermined appears to have progressed but no photos were taken due to the dense vegetation covering area. According to Tony Martinez, LMA representative, the WS concrete headwall has been detached since 2008/2009. LMA has been in contact with CVFPB, DWR, and USACE regarding this site. (O. Magana - DWR UCIP)10/01/2013 Headwall on WS toe separated from pipe. Erosion around concrete headwall and undermined at WS toe. Flap gate missing from WS toe headwall. (W. Wylie - DWR UCIP)

Slide gate in concrete riser next to shed on WS shoulder.

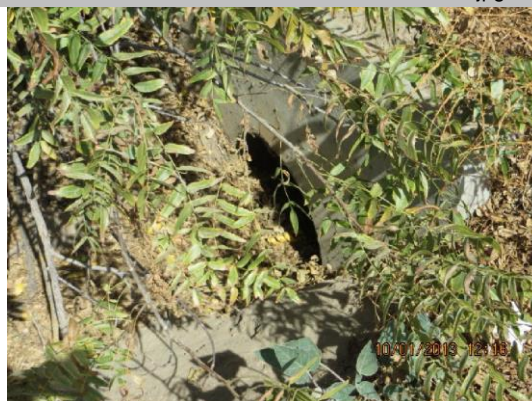
Photo 3 of 3 : UCIP_FA_2018_51336_36820.jpg

Comment Code						
Inspector Comment						
FS_ID:51336 DS_ID:20208 EP_NO: N/A Repair Type: Non-Urgent Crossing Status: Found UCIP Comments: 11/18/2016 Same as previous inspection soil and debris prevent flap gate from properly functioning and slide gate won't close due to sediment build up. Crossing has been downgraded from Urgent to Non-Urgent due to no pipe or levee integrity issues observed during the site visit. Need to contact owner to determine status of crossing. If crossing is no longer in use owner will need to coordinate with CVFPB to properly abandon or remove according to Title 23 requirements. (O. Magana - DWR UCIP)10/01/2013 Soil and debris prevent flapgate from proper function. Slide gate won't close completely due to sediment buildup. CMP riser needs cover. (W. Wylie - DWR UCIP) FIELD_STRUCT_DESC: 24-inch steel pipe through levee, 11.6 feet below crown. Concrete headwall on the landside (LS) end. Concrete "U" headwall and flap gate located on the waterside (WS) end. Slide gate in 60-inch corrugated metal pipe (CMP) riser is located on the WS slope. [Additional Reference(s): DWR Levee Log, 1992. USACE San Joaquin River O&M Manual Unit 13, April 1964, (HLM 5.23), Drawing No. 7-4-1784]. FS Date: 11/18/2016

Concrete headwall at inlet on LS toe.

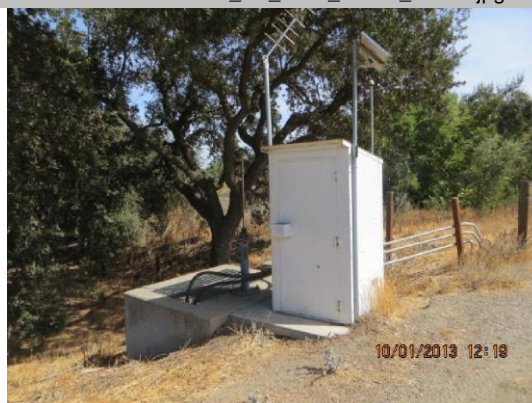
Photo 1 of 2 : UCIP_FA_2018_21665_36829.jpg

Comment Code					
Inspector Comment					
FS_ID:21665					
DS_ID:20209					
EP_NO: 8192					
Repair Type: No Action Needed					
Crossing Status: Found					
UCIP Comments:					
FIELD_STRUCT_DESC: 1 of 2: 36-inch by 36-inch reinforced concrete box drainage culvert through the levee, 15.8 feet below the crown. Slide gate in a 6-foot by 7-foot concrete surge box on the waterside (WS) slope. 36-inch concrete pipes buried on both sides of the levee and connected to the reinforced concrete box culvert. Constructed through the levee section. (two 36-inch by 36-inch culvert [HLM 5.27] authorized under Automatic Board Order (ABO) issued as Permit No. 8192, 1972 - Stanislaus County). [Additional Reference(s): DWR Levee Log, 1992. USACE San Joaquin O&M Manual 13, April 1964, (HLM 5.27), Drawing No. 7-4-1784].					
FS Date: 10/1/2013

Shed with slide gate in Concrete riser on WS shoulder.

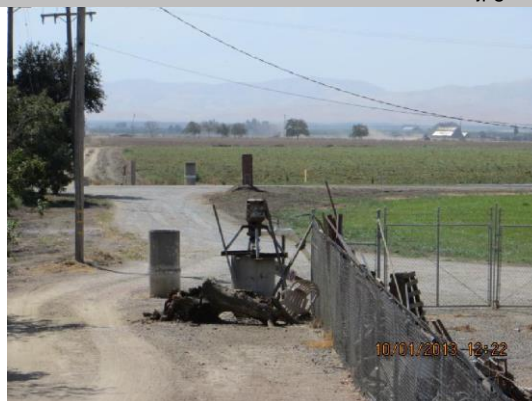
Photo 2 of 2 : UCIP_FA_2018_21665_36828.jpg

Likely risers for pipe off LS toe.

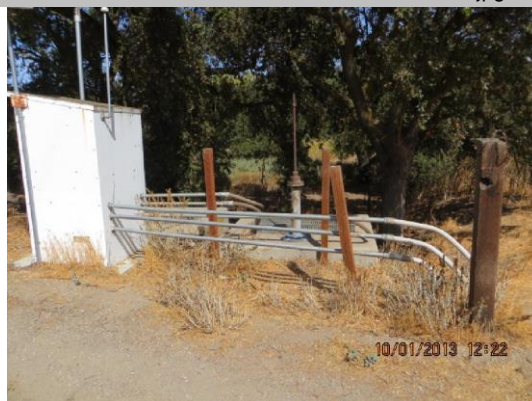
Photo 1 of 2 : UCIP_FA_2018_21668_36835.jpg

Comment Code						
Inspector Comment						
FS_ID:21668 DS_ID:20222 EP_NO: 8192 Repair Type: No Action Needed Crossing Status: Found UCIP Comments: FIELD_STRUCT_DESC: 2 of 2: 36-inch by 36-inch reinforced concrete box drainage culvert through the levee, 15.8 feet below the crown. Slide gate in a 6-foot by 7-foot concrete surge box on the waterside (WS) slope. 36-inch concrete pipes buried on both sides of the levee and connected to the reinforced concrete box culvert. Constructed through the levee section. (two 36-inch by 36-inch culvert [HLM 5.27] authorized under Automatic Board Order (ABO) issued as Permit No. 8192, 1972 - Stanislaus County). [Additional Reference(s): DWR Levee Log, 1992. USACE San Joaquin O&M Manual 13, April 1964, (HLM 5.27), Drawing No. 7-4-1784]. FS Date: 10/1/2013

Slide gate in Concrete vault on WS shoulder.

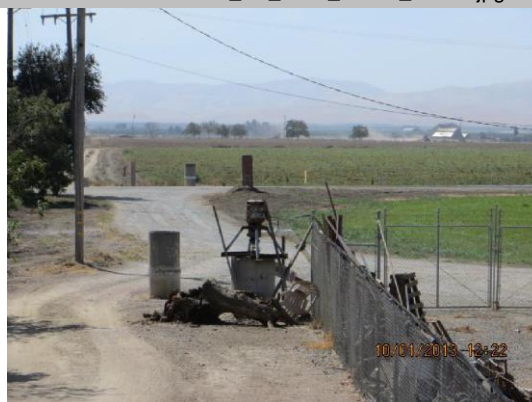
Photo 2 of 2 : UCIP_FA_2018_21668_36834.jpg

Possible concrete risers for pipe off LS toe.

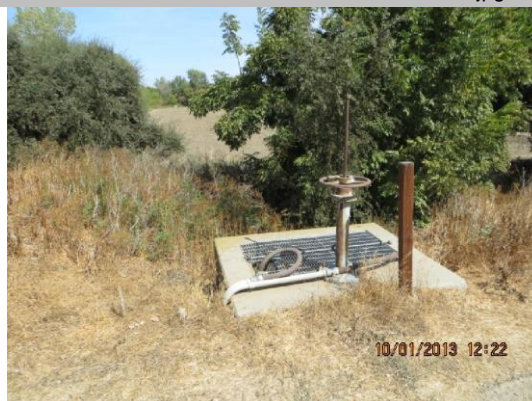
Photo 1 of 3 : UCIP_FA_2018_21672_36848.jpg

LM Start	5.24	Rating **	A/W	Issue No.	212
LM End	5.24	Issue Type +	Ma	Location *	
Category	Supplemental			GPS Latitude/Longitude	
				Start	End
Item	DWR UCIP LMA Responsibility			37.436129°	37.436129°
				-121.036065°	-121.036065°
DWR ID	20210				
Comment Code					
Inspector Comment					
FS_ID:21672 DS_ID:20210 EP_NO: N/A Repair Type: No Action Needed Crossing Status: Found UCIP Comments: FIELD_STRUCT_DESC: 30-inch by 30-inch reinforced concrete box drainage culvert through the levee, 12.9 feet below the crown. Slide gate in a concrete surge box on the waterside (WS) slope. Concrete discharge boxes on both ends. [Additional Reference(s): DWR Levee Log, 1992. USACE San Joaquin O&M Manual 13, April 1964, (HLM 5.28), Drawing No. 7-4-1784]. FS Date: 10/1/2013

Slidegate in concrete riser on WS shoulder.

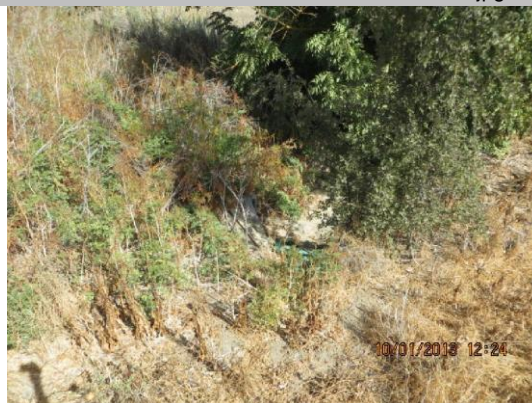
Photo 2 of 3 : UCIP_FA_2018_21672_36847.jpg

Concrete outlet on WS toe.

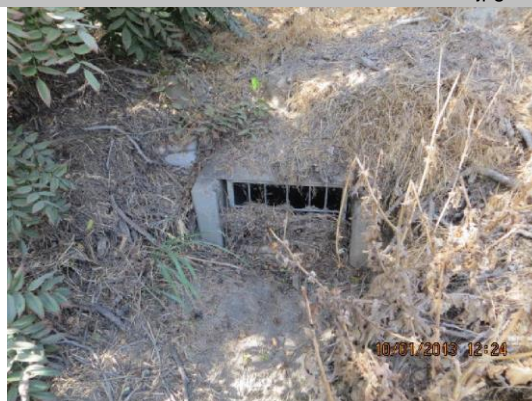
Photo 3 of 3 : UCIP_FA_2018_21672_36846.jpg

LM Start	5.24	Rating **	A/W	Issue No.	212 (cont)	
LM End	5.24	Issue Type +	Ma	Location *		
Category	Supplemental			GPS Latitude/Longitude		
				Start		End
Item	DWR UCIP LMA Responsibility			37.436129 °		37.436129 °
				-121.036065 °		-121.036065 °
DWR ID	20210					
Comment Code						
Inspector Comment						
FS_ID:21672 DS_ID:20210 EP_NO: N/A Repair Type: No Action Needed Crossing Status: Found UCIP Comments: FIELD_STRUCT_DESC: 30-inch by 30-inch reinforced concrete box drainage culvert through the levee, 12.9 feet below the crown. Slide gate in a concrete surge box on the waterside (WS) slope. Concrete discharge boxes on both ends. [Additional Reference(s): DWR Levee Log, 1992. USACE San Joaquin O&M Manual 13, April 1964, (HLM 5.28), Drawing No. 7-4-1784]. FS Date: 10/1/2013

Concrete inlet on LS toe.

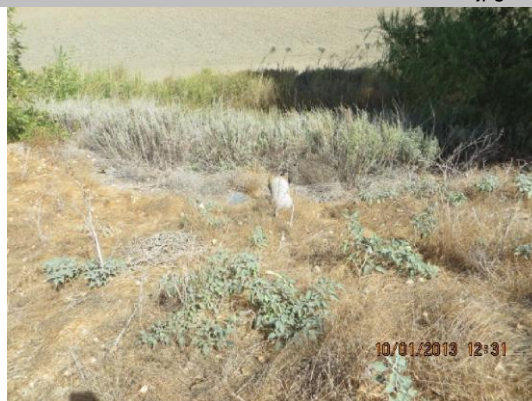
Photo 1 of 1 : UCIP_FA_2018_21674_36854.jpg

LM Start	5.46	Rating **	M	Issue No.	213	
LM End	5.46	Issue Type +	Ma	Location *		
Category	Supplemental			GPS Latitude/Longitude		
				Start	End	
Item	DWR UCIP LMA Responsibility			37.433646 °	37.433646 °	
				-121.033846 °	-121.033846 °	
DWR ID	20211					
Comment Code						
Inspector Comment						
FS_ID:21674 DS_ID:20211 EP_NO: N/A Repair Type: Non-Urgent Crossing Status: Found UCIP Comments: 10/01/2013 Pipe appears abandoned and if so should be done so properly. (W. Wylie - DWR UCIP) FIELD_STRUCT_DESC: *ABANDONED* 12-inch drainage pipe of an unknown material through the levee, 6.9 feet below the crown. Flap gate on the waterside (WS) end. Could not locate, March 1984. (Reclamation District No. 1602). [Additional Reference(s): DWR Levee Log, 1992. USACE San Joaquin O&M Manual 13, April 1964, (HLM 5.50), Drawing No. 7-4-1784]. FS Date: 10/1/2013

Pipe and flapgate visible on WS toe.

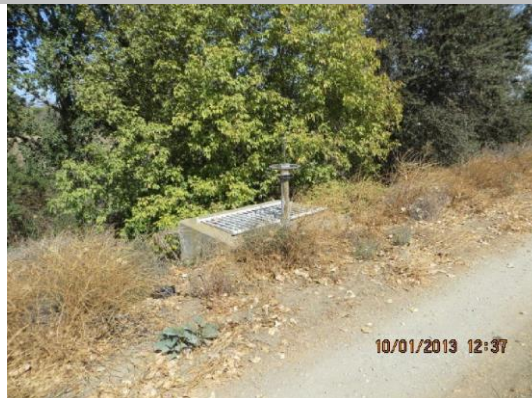
Photo 1 of 3 : UCIP_FA_2018_51337_36878.jpg

Slide gate in concrete riser on WS shoulder.

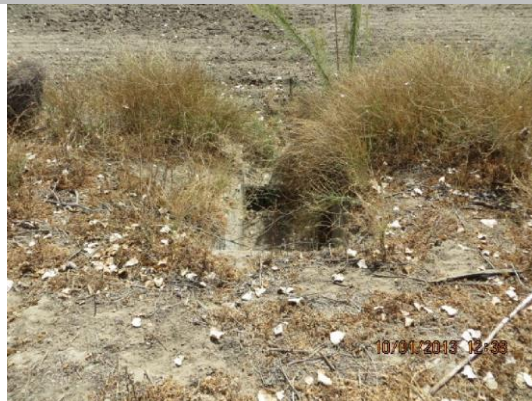
Photo 2 of 3 : UCIP_FA_2018_51337_36877.jpg

Concrete U-shaped headwall on LS toe.

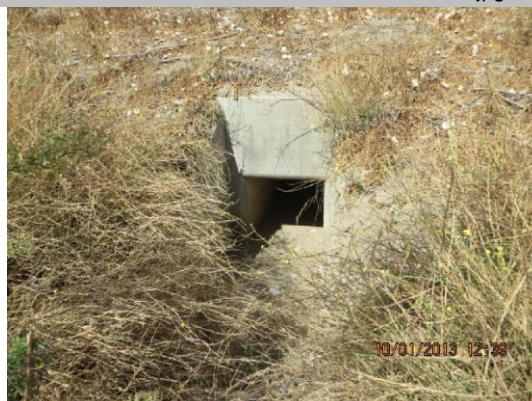
Photo 3 of 3 : UCIP_FA_2018_51337_36876.jpg

Comment Code					
Inspector Comment					
FS_ID:51337 DS_ID:20212 EP_NO: N/A Repair Type: Non-Urgent Crossing Status: Found UCIP Comments: 11/18/2016 Crossing has been downgraded from Urgent to Non-Urgent flap gate is functional. Recommend clearing dense vegetation from WS and LS slopes. (O. Magana - DWR UCIP)10/01/2013 Flapgate has minor blockage preventing gate from fully closing. (W. Wylie - DWR UCIP) FIELD_STRUCT_DESC: 30-inch square reinforced concrete box culvert through levee, 9 feet below crown. Slide gate in concrete surge box is located on the waterside (WS) slope. Concrete "U" headwalls are located on both the waterside (WS) and landside (LS) ends. Flap gate is located on the WS end. [Additional Reference(s): DWR Levee Log, 1992. USACE San Joaquin River O&M Manual Unit 13, April 1964, (HLM 5.28), Drawing No. 7-4-1784]. FS Date: 11/18/2016

Concrete U-shaped headwall on LS toe.
